Corrosion Prevention of Rebar in Concrete in Critical Facilities Located in Coastal Environments at Okinawa

Final Report on Project FAR-16 for FY06

August 2009

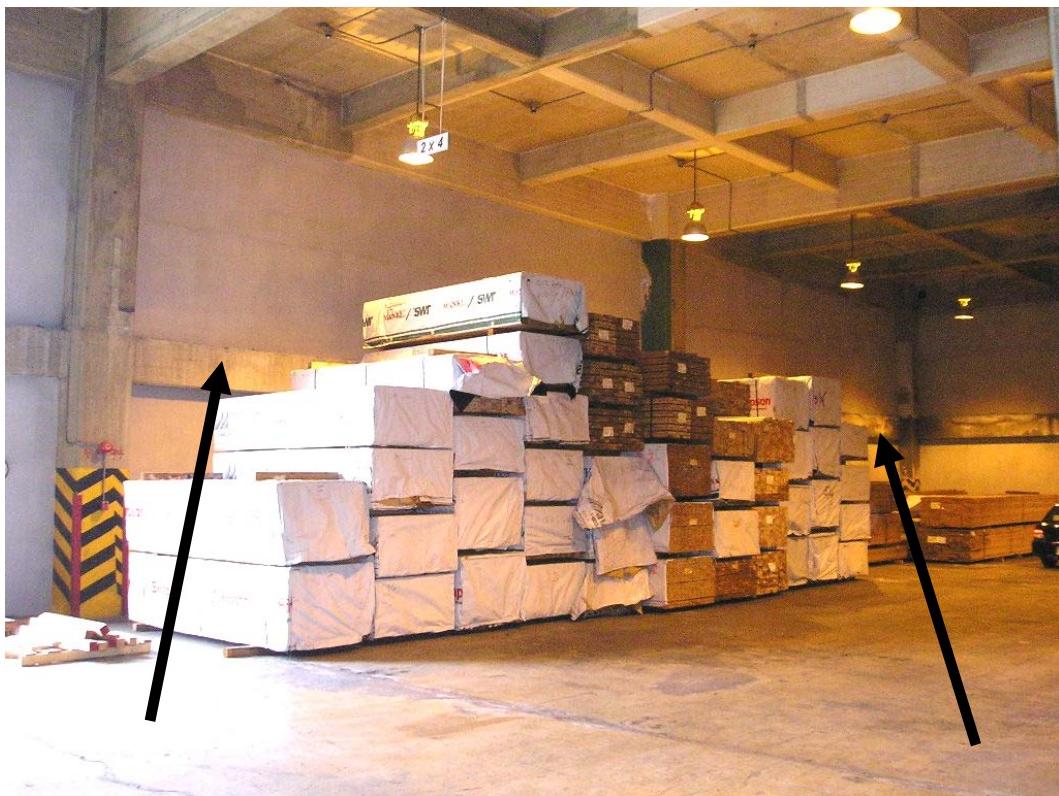
Figure 2.1. Building 306 warehouse, inside ring girder, side 1 (left) and side 2 (right).

One structure selected for demonstration of the technologies was Building 306, a warehouse located at Naha Military Port. Two equal-size portions of a ring girder in area A of the building were designated for treatment, positioned on opposite sides of the darker column shown near the center of Figure 2.1. Side 1 was designated for application of the Surtreat corrosion inhibitor system, and side 2 was designated for application of the NASA-developed LGC. Figure 2.2 shows the condition of side 2 of the ring girder before treatment.

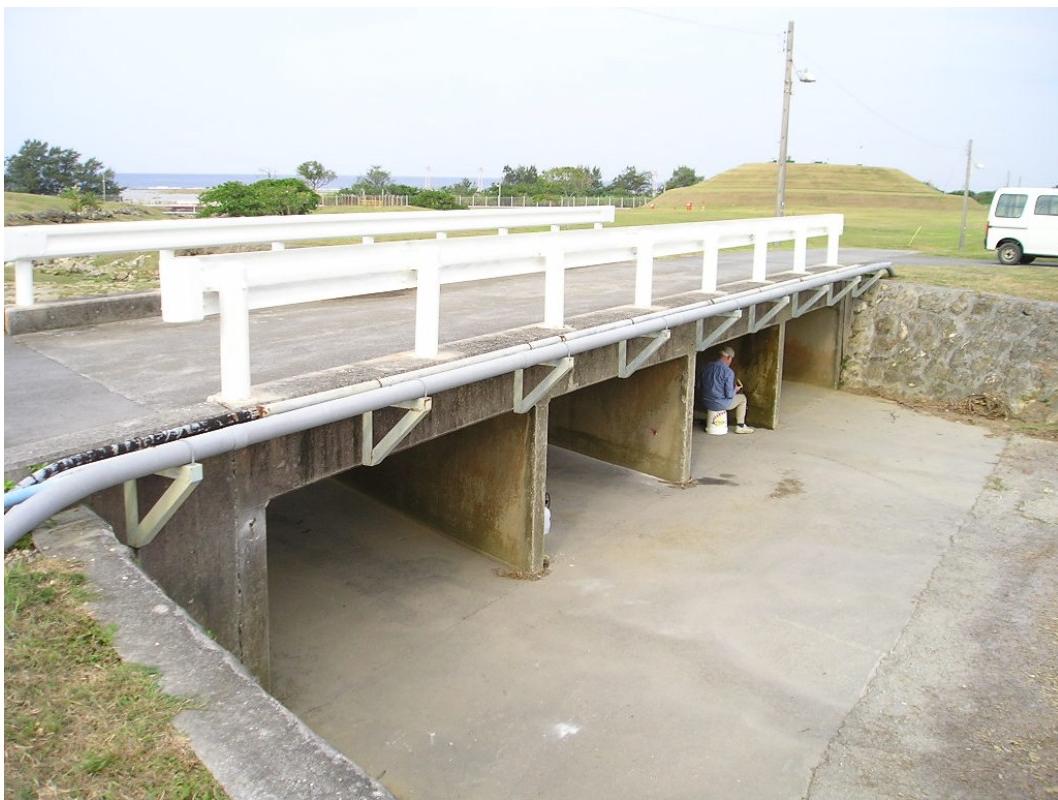
Figure 2.3. Tank farm culvert 2, all concrete surfaces.

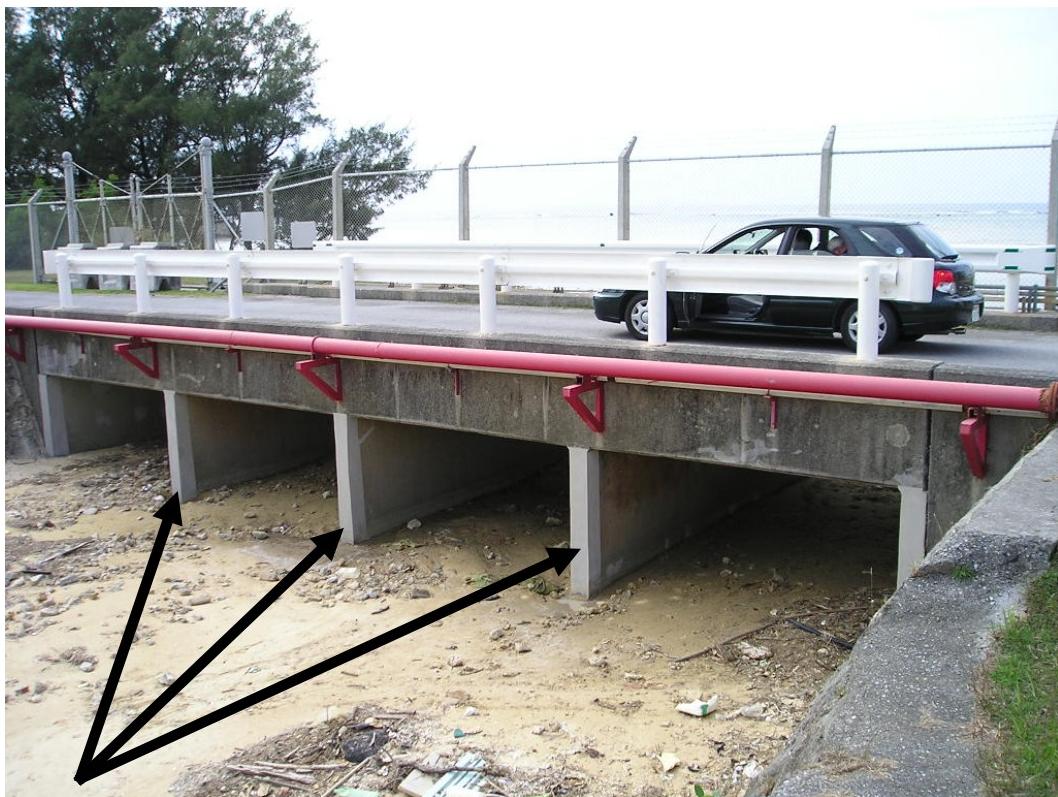
Figure 2.4. Tank farm culvert 3, vertical concrete support components.

No tests were performed on culvert 3. Based on visual inspection, culvert 3 was assumed to be similar to culvert 2 in all respects that would affect corrosion prevention and control treatments.

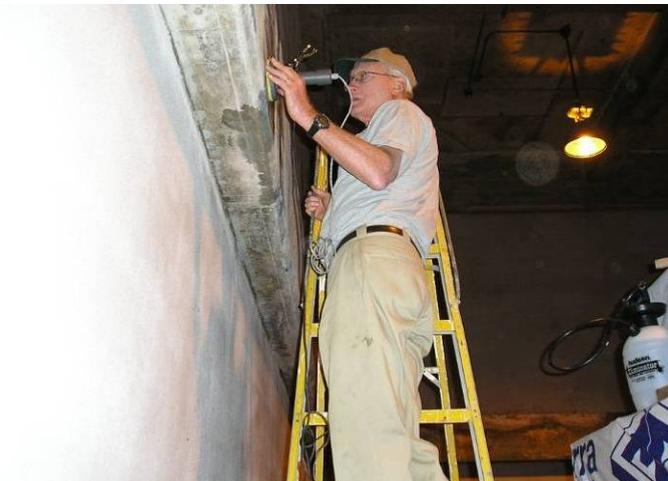
Corrosion rate test

Corrosion testing showed average corrosion rate of 10 $\mu\text{M}/\text{year}$, confirming the presence of corrosion in addition to the apparent symptoms like delamination at rebar level, spalling and surface rust stains. The test was carried out using Germann Instruments Galvapulse® method.

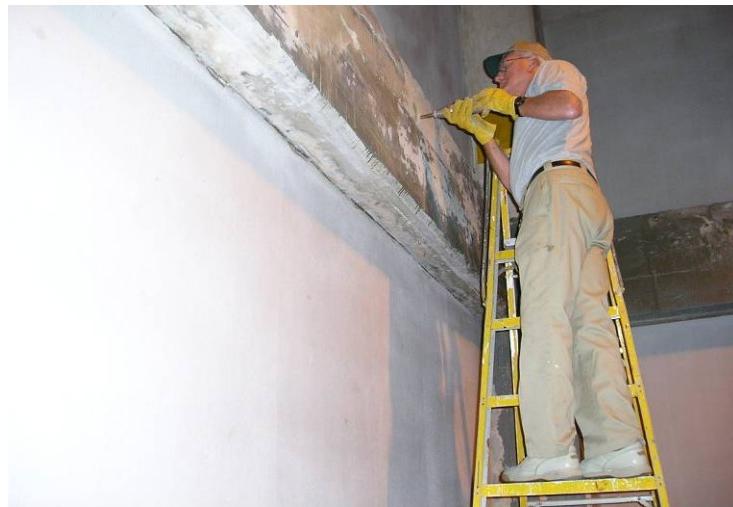
Compressive strength test

Compressive strength testing showed an average of approximately 3,000 psi using rebound hammer.

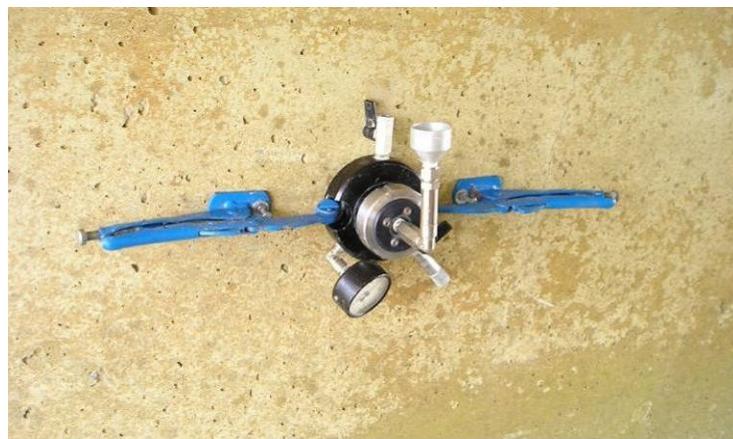
**Kuwae culvert 2***Water permeability test*

Water permeability showed permeability of 3.6 ml/min at a constant pressure of 1.5 bar (~22 psi.). This value can be described as above average. The test was conducted using GWT® method and Germann Instruments static pressure cell.

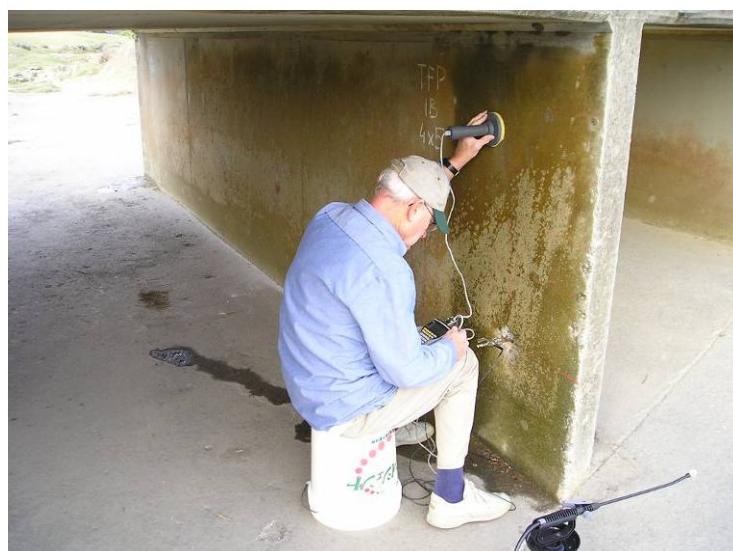
Corrosion rate test

Corrosion rate was measured at three locations on bridge supports. Tests were conducted using the Germann Instruments Galvapulse® method. Test area A showed the average corrosion rate of 34 $\mu\text{M}/\text{year}$; test area B showed the average corrosion rate of 35 $\mu\text{M}/\text{year}$; and test area C showed the average corrosion rate of 38 $\mu\text{M}/\text{year}$. Based on these findings condition of the embedded steel bar can be described as corrosive.

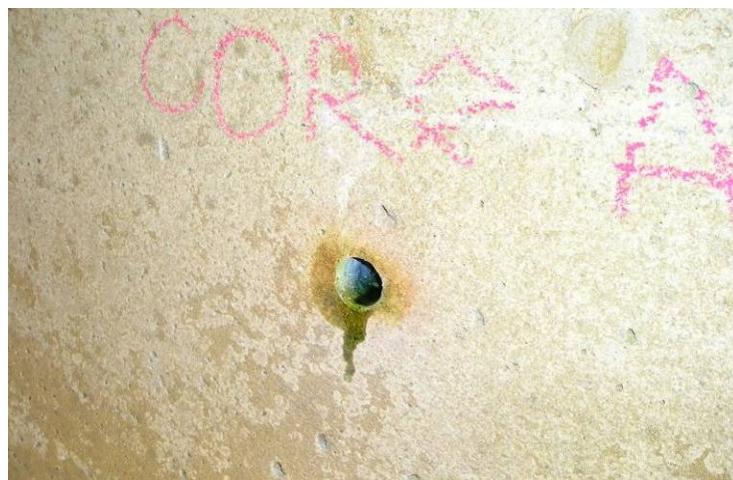
pH test

Concrete pH was measured using Rainbow pH Indicator® and showed loss of concrete pH at the surface. Tests were performed in two locations, and returned similar results.

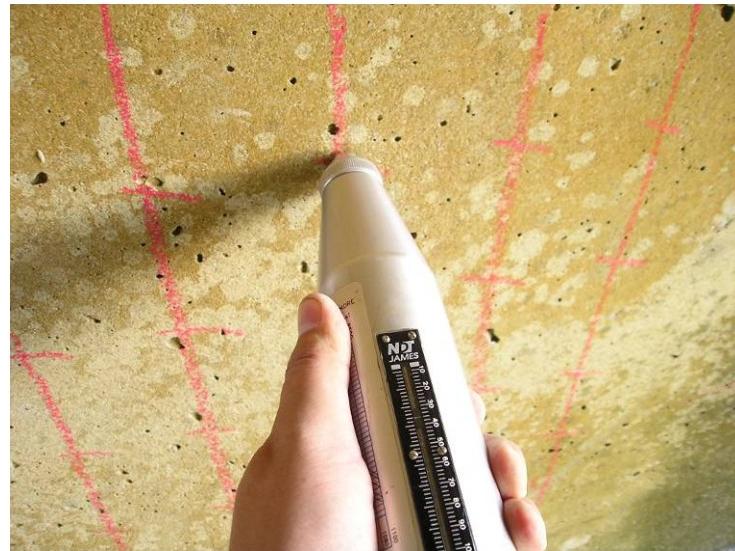
Compressive strength test

Rebound hammer was used to estimate compressive strength at approximately 4,000 psi. Tests were conducted in two locations and returned similar results.

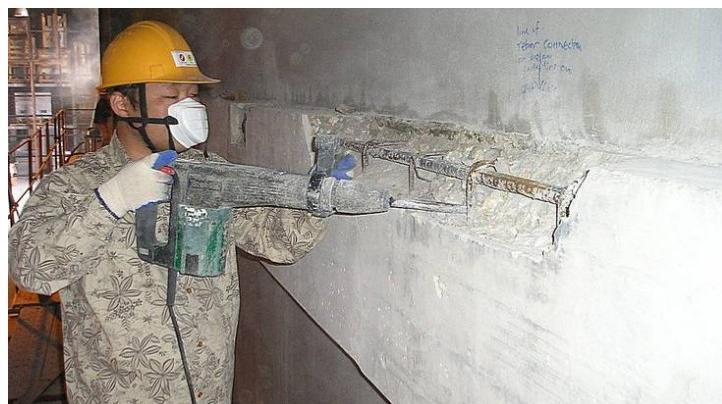
Failed existing repairs and new delaminated areas were demolished.

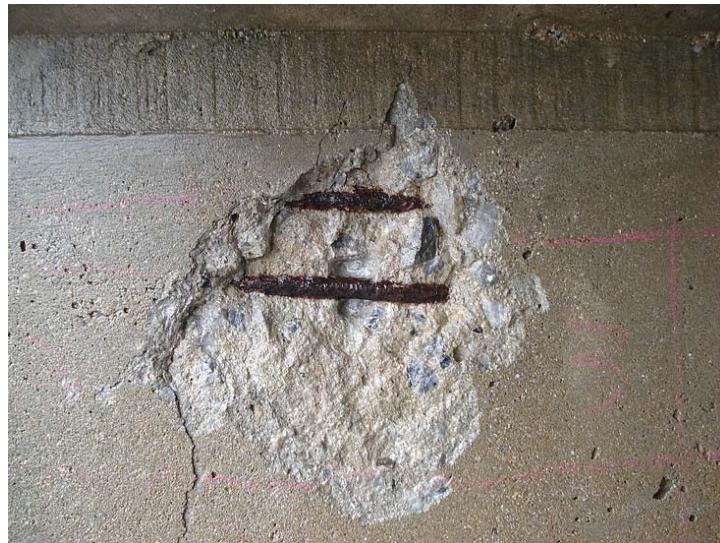
Deterioration and spalling pattern common to Culvert 2.

All repair areas were “squared” and patched using locally manufactured overhead mortar.

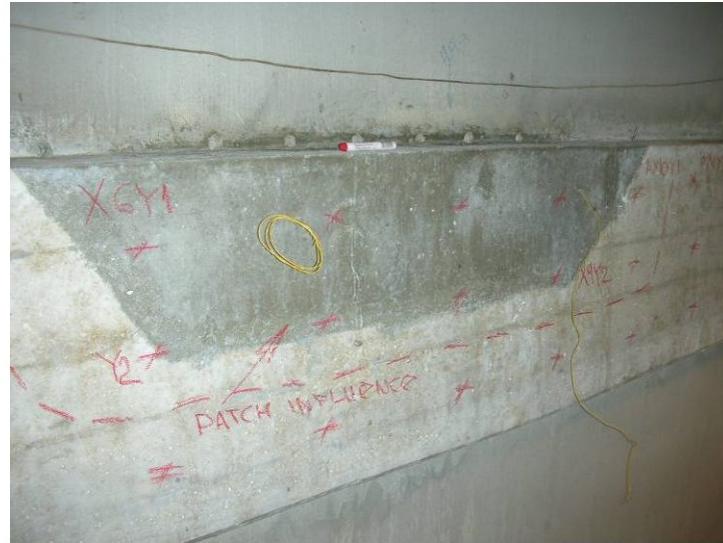
The points on the grid established during initial testing match exactly the points of the follow-up testing. The photograph also shows where the measurements were influenced by additional wire inside the repair installed to hold the patch in place during curing. During initial testing some of the repair areas could not be tested due to spalling.

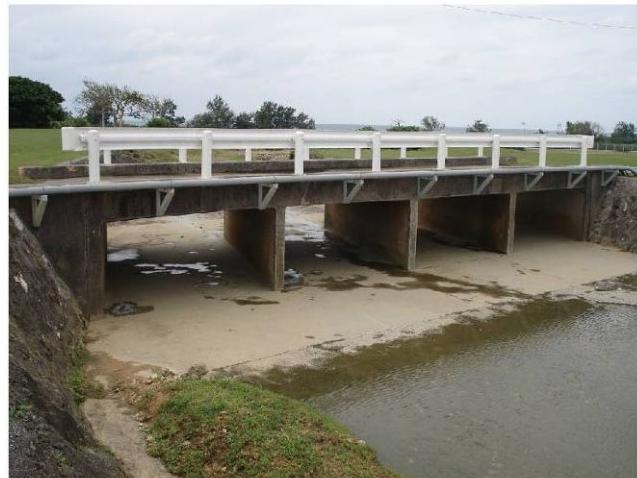
Culvert #2 is located in the middle of the spillway section within the tank farm. Figure 1 shows a general overview of the culvert, looking downstream toward the East China Sea. Light rains with periodic heavy rain throughout the first day of inspections resulted in brisk water flow through the culvert, as much as a foot deep. Sketches 2 and 3 (Appendix A) depict the existing condition of the pier walls on Culvert #2 as well as the location of all tests conducted. Generally, the form dimensions were easily visible and could be used as reference points.

Figure 1. Overview of Culvert #2, looking downstream toward the East China Sea.

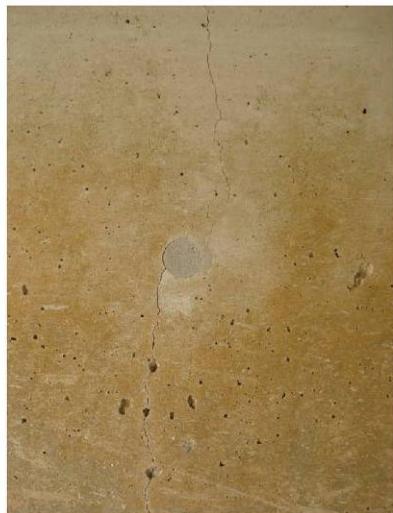
Overall, the concrete appeared to be in good shape. Vertical cracks were observed in the center of each pier and abutment. The approximate locations of these cracks are noted in the sketches. No evidence of previous repairs was observed (except for one bug hole which was patched with some type of mortar). The surface was smooth except for bug holes and form marks. The surface was stained brown along most of the pier surfaces. A typical surface is shown in figure 3. The upstream leading edge of the pier was deteriorated (likely by abrasion or impact of debris), with chunks up to three inches removed. Figure 4 shows typical damage on the upstream edge of the culvert piers.

Figure 3. Typical pier wall surface containing a crack and plugged area.

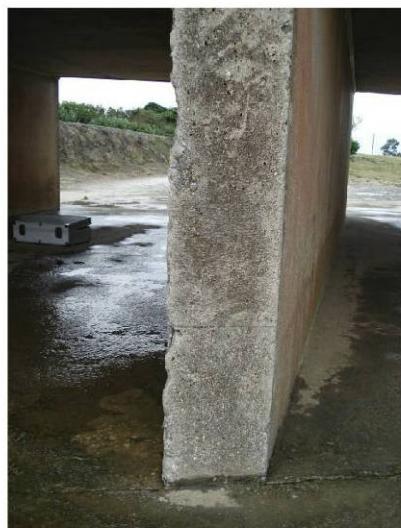
Figure 4. Typical damage on the upstream edges of the culvert #2 piers.

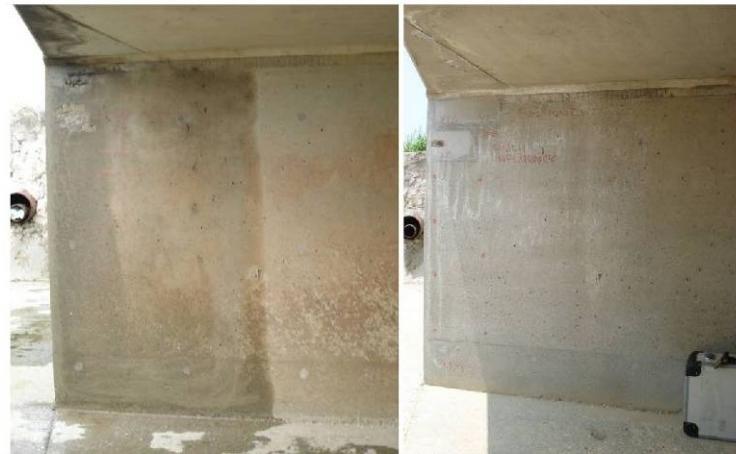
Figure 5. Typical appearance of culvert before (left) and 6 months after (right) inhibitor application.

Several small patches of cementitious repair material were noted on the structure at the July inspection. These patches were applied by others between completion of the Surtreat work and our July inspection. Details regarding the reason for repair and the procedures used are not known. Figure 6 shows typical repairs. Note that the repair material has a rough appearance and is beginning to exhibit cracking.

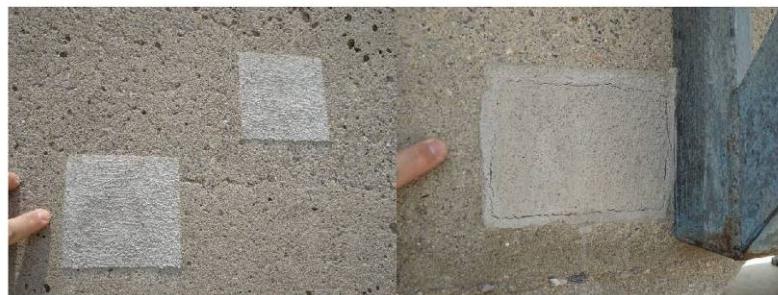
Figure 6. Typical repairs performed by others.

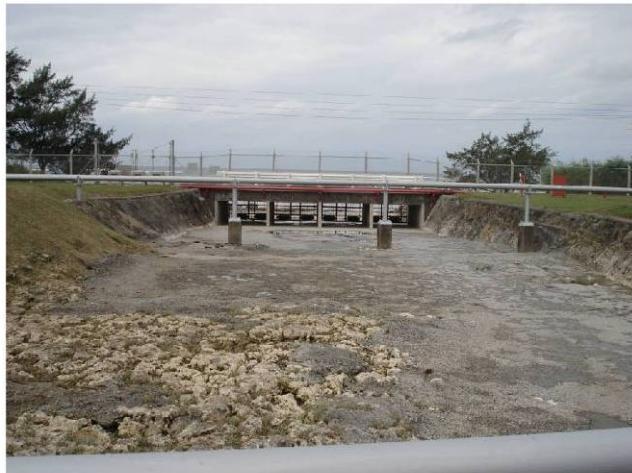
Culvert #3 is located at the extreme western end of the spillway (i.e., nearest to the East China Sea). Figure 11 shows a general overview of the culvert looking toward the East China Sea. Sketches 4 and 5 (Appendix A) depict the existing condition of the pier walls on Culvert #3.

Figure 11. Overview of Culvert #3, looking downstream toward the East China Sea.

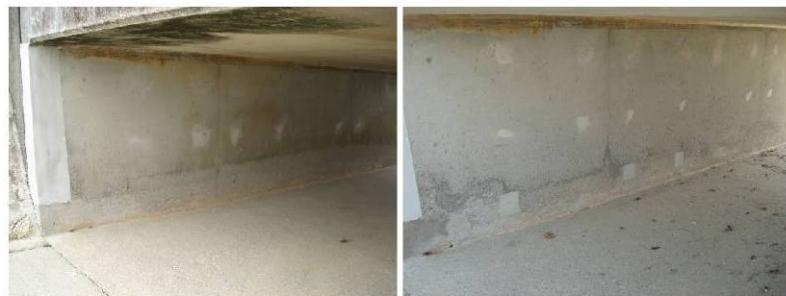
The Surtreat inhibitor system was applied to the piers of the structure in early February, 2007. During our July, 2007 inspection the structure appeared to be in good condition. However, it was observed that vertical cracks on several of the piers had a cementitious repair material applied over them. Details of the repair work are not known. Figure 14 shows the south abutment face in January and July 2007. Note the patch repair that was completed as well as the overall improvement in appearance of the concrete associated with the cleaning and application of the inhibitor.

Figure 14. Typical appearance of culvert before (left) and 6 months after (right) inhibitor application.

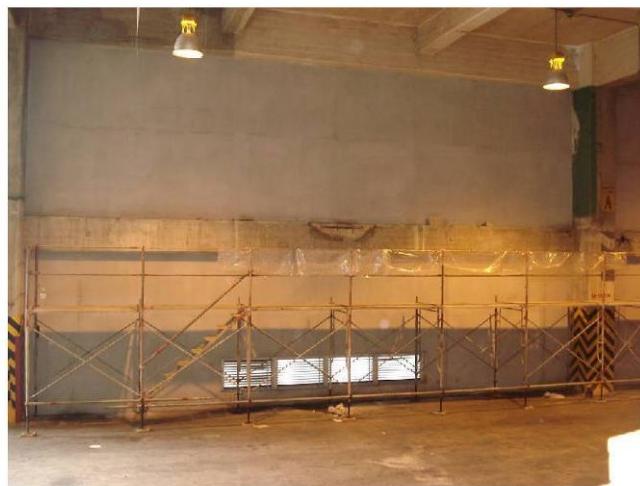
Tests were conducted on a ring girder along the west end of Building 306 at the Naha military port. The beam is approximately 25 inches high by 7 inches thick. There are two sections of beam to be repaired, each approximately 38 feet long. The section of the ring girder designated "Beam 1" begins immediately adjacent to the door and continues to an intersection with a vertical column. The section of the ring girder designated "Beam 2" is the section which begins on the other side of the vertical column and ends at the column in the corner of the building. Sketches 6 and 7 (Appendix A) show significant features of Beams 1 and 2, respectively. Figures 15 and 16 show overviews of Beam 1 and Beam 2, respectively.

Figure 15. Overview of "Beam 1" at Naha Port Building 306.

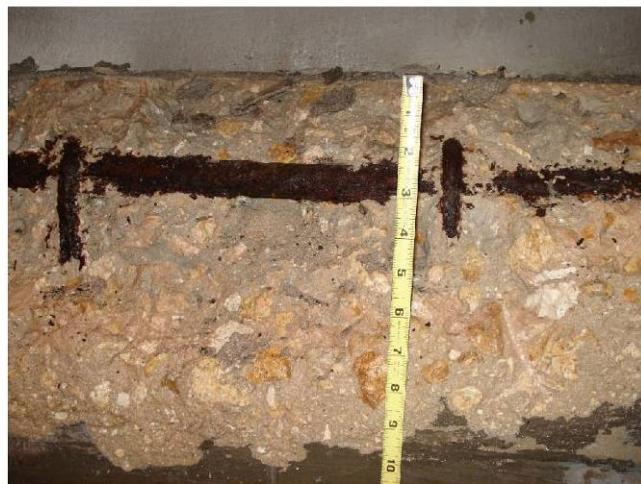
Figure 17. Representative exposed rebar at a repair location.

On January 18, Surtreat personnel exposed rebar under spalled concrete in two locations on each beam. The exposed rebar was heavily corroded. While the corrosion could not be measured precisely, there was evidence of several millimeters of corrosion. Figure 17 shows a typical section of exposed rebar. The rebar was approximately 1½-inch diameter running along the beam. The rebar spacing was approximately seven inches with the top bar approximately three inches from the top of the beam. Vertical rebar "cages" were smaller and placed approximately every 13 inches. Rusted attachments were scattered along the surface of the beams (cut off screws, staples, anchors, etc). Beam 2 had some type of paint applied in the past. It was fairly thin (several mils), gray paint which was peeling in most areas.

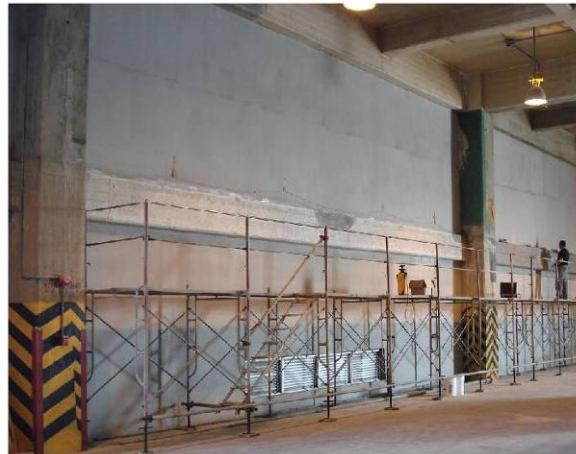
The portion of the ring girder designated “Beam 1” was treated with the Surtreat inhibitor system and had delaminated sections repaired in early February, 2007. Figure 18 shows the beam during our July visit. Several patches are evident along the top of the beam, including one large patched area to the right of center and smaller ones at either end of the beam. The edges of the repair material appear to be well bonded. Aside from the patches, the remainder of the beam is cleaned to a uniform appearance. Compare Figure 18 (after) to Figure 15 (before).

Figure 18. Overview of Beam 1 in July, 2007.
Note patch repairs (darker appearance). Compare to Figure 15.

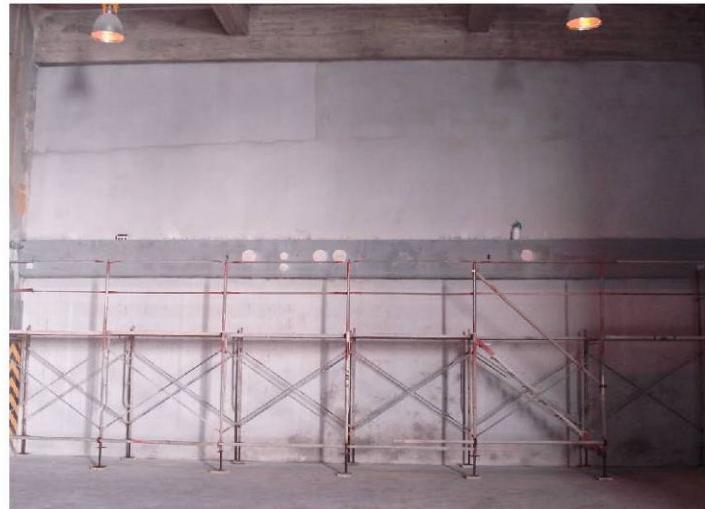
Figure 22 shows an overview of the beam during our July visit. The circular areas are where the coating has been ground away to facilitate corrosion rate and electrochemical potential measurements. These areas of missing coating should not impact the overall performance of the sacrificial coating. The applied coating had some thick areas, evidenced by visible cracking or sagging. Generally, the coating appeared to be well adhered and uniformly covered the concrete surface. Three titanium mesh strips are embedded in the coating lengthwise along the beam. These strips provide redundant collection points to be connected to the reinforcing steel. Figure 23 shows a closer view of the three mesh strips. The yellow wires provide electrical continuity between the mesh strips and the reinforcing steel.

Figure 22. Overview of Beam 2 with the NASA sacrificial coating applied.

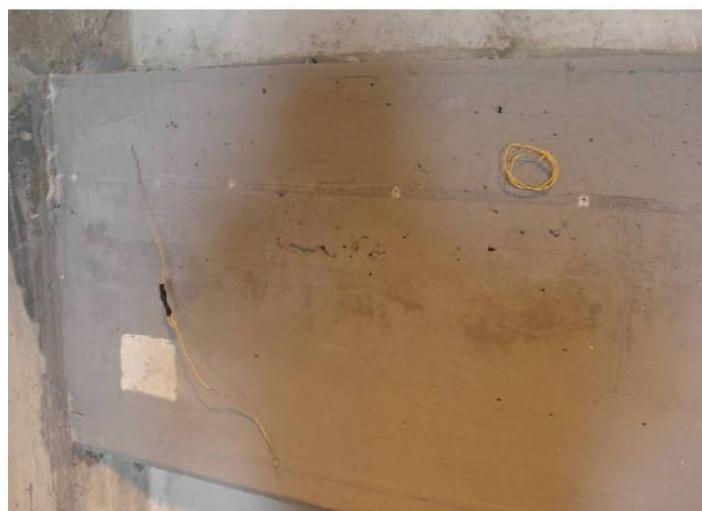
Figure 23. Close up showing titanium mesh connections in sacrificial coating.

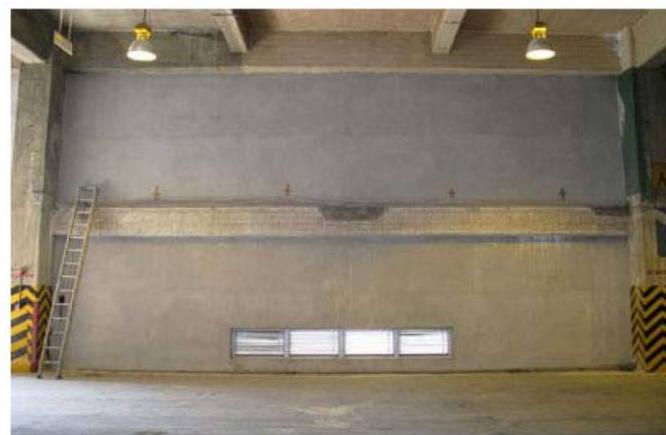
Figure 1f. Overall view of beam "AA" after treatment; reportedly treatment consisted of vapor and liquid inhibitor application to the concrete beam surface

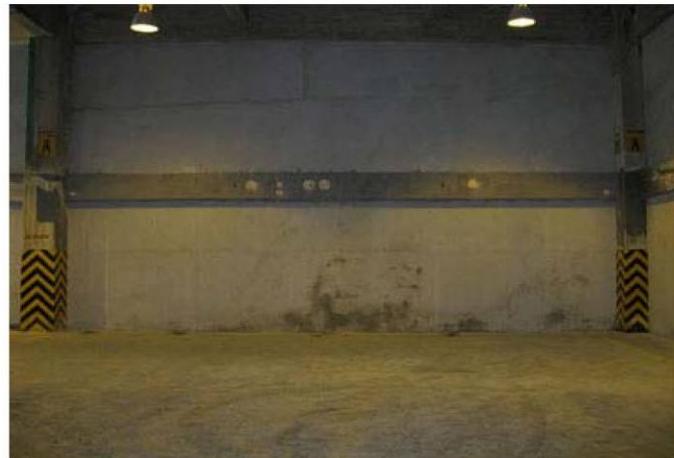
Figure 1g. Overall view of beam "A" after treatment; reportedly a zinc-aluminum-indium rich coating was applied to the concrete beam surface

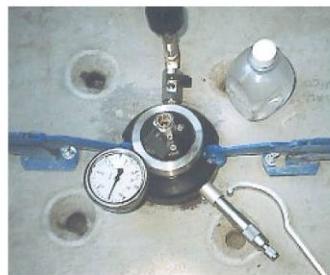
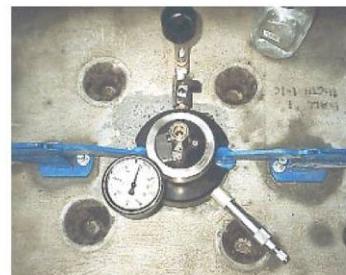
High performance concrete being tested with the GWT. The four cone holes shown adjacent are from CAPO-TEST. At a pressure of 1 BAR (right photo) water was observed to penetrate through surface cracks. After grinding 1.5 mm deep the test was repeated (left photo), and the pressure increased to 5 BAR. No penetration through cracks was observed. A water flux of $1.3 \times 10^{-5} \text{ mm/s}$ was measured.
